IPS Control: 1060244

Location: Richmond/CWT

Cooling Water Fan Where
Employee Fell

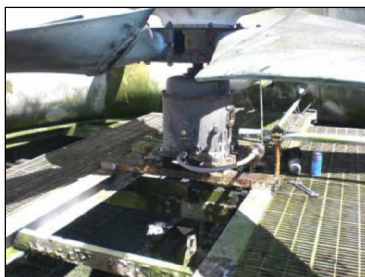
On Wednesday, June 18th, 2008, a mechanic fell approximately 10-12 feet inside a Cooling Water Tower (CWT) after falling through a plastic diffuser. The incident took place when three maintenance employees were working on a fan on the LSFO East Cooling Water Tower. While servicing the fan, one employee untied the fan blades to work oil through the fan gearbox. As he manually rotated the fan blade, the blade unexpectedly hit a second mechanic who was entering the fan blade area. This caused him to lose his balance and fall into the CWT.

- 1) Mechanic A was not aware of mechanic B's position when he manually rotated the fan blades. If he had been aware of the second mechanic's position, he would have waited to rotate the blades until mechanic B was outside of the blade's reach.
- 2) There was an insufficient area of load bearing material as a walking / work surface and personal fall protection was not used. It appears there was insufficient appreciation of the fall hazards involved in this work.
- 3) The confined space entry requirements for this work will be reviewed as part of developing best practice guidelines for maintenance work inside CWT fan shrouds.

- 1) Reinforce communication expectations for performing this type of work. Richmond refinery is considering developing a JLA regarding peer-to-peer communications when job conditions change.
- 2) Assess if it is possible to permanently install grating able to support the weight of a person in CWT fan access areas.
- 3) Issue instructions to maintenance personnel for temporary installation of complete load bearing coverage below a CWT shroud when entry is necessary until a permanent load bearing grating (if possible) is installed.
